CONDITION ASSESSMENT

Better data, better evaluations

New inspection technology using multi-sensor data can provide more accurate condition assessments. Jeff Griffiths and Jeff Graham discuss a recent US project

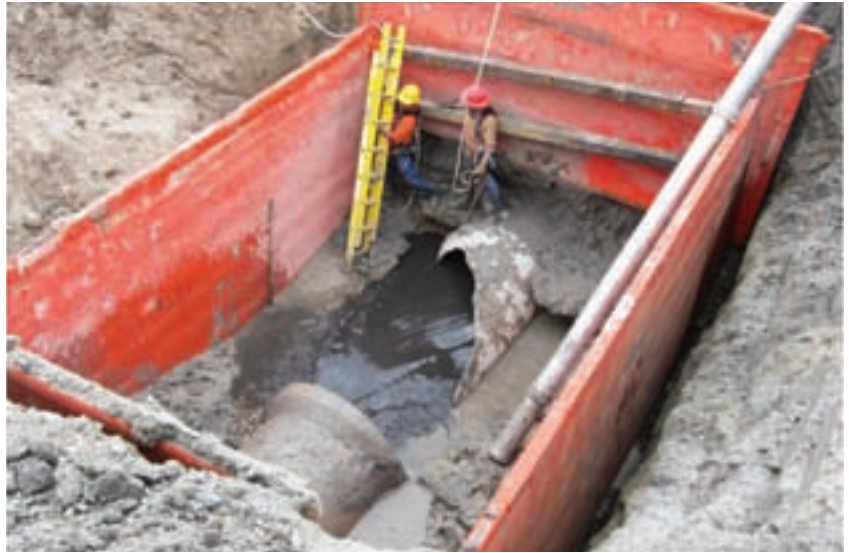
The importance of understanding the structural condition of the city sewers was realised during the earliest stages of the study, when a 1,215mm section of a reinforced-concrete main trunk line failed. Evidence appeared to indicate that hydrogen sulphide corrosion led to the failure.

The original pipe wall thickness was estimated to be 125mm; however, some sections showed thicknesses of less than 25mm at the crown, with a complete absence of steel reinforcement. This corrosion appears to be confined to the area above the normal waterline, which is consistent with failure from hydrogen sulphide corrosion.

Failure of 1,215mm RC main sewer

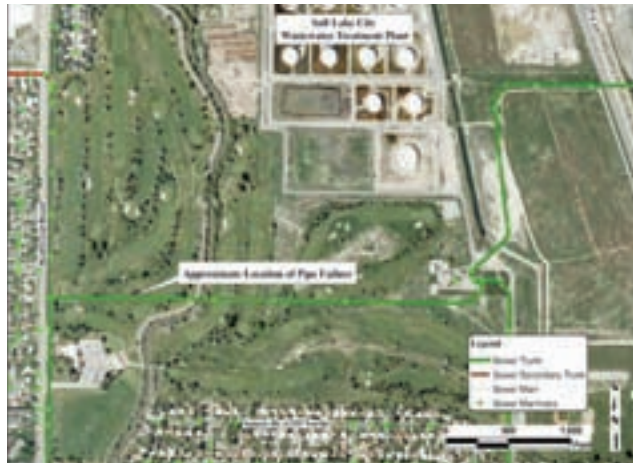
Location of pipe failure

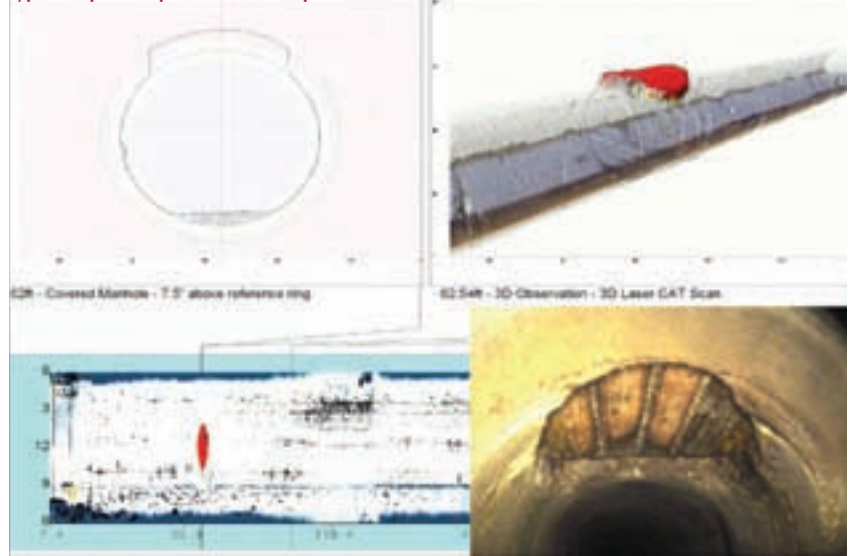
Typical report output, based on inspection data
