HYDROMAX USA

CASE STUDY

Hydromax USA Aids the City of Virginia Beach, VA with Pipeline Replacement & Rehab Project

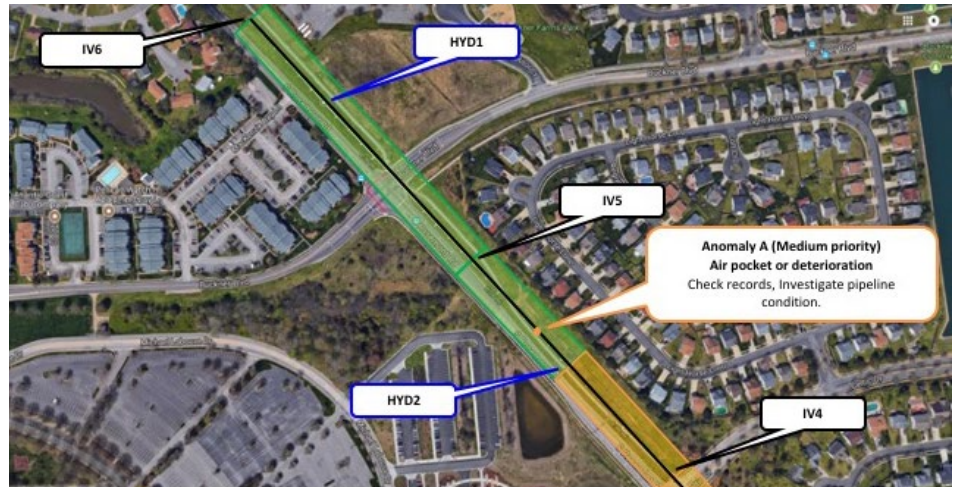
- 32% of pipeline tested was **HIGHLY DETERIORATED**
- 65% of pipeline tested was **MODERATELY DETERIORATED**
- 2 HIGH PRIORITY and 11 MEDIUM PRIORITY anomalies were identified which included valves that were not fully sealed, pipe material change and entrapped air.

Sample Visual Summary of Sub-Section Analysis Report
