Nautilus™ Solves Large Diameter Water Loss Challenges in Colorado

CASE STUDY

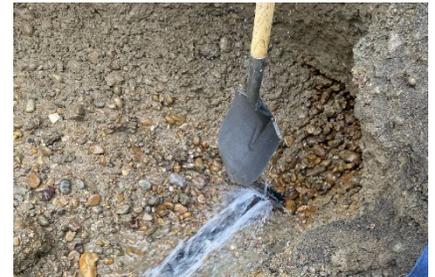
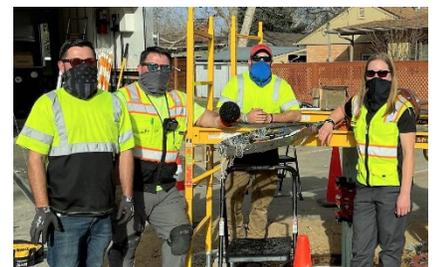
Nautilus navigated both pipelines with ease. Results from the Nautilus audio recording indicated the transmission pipelines were predominantly intact, apart from a significant leak where the 20-inch main intersected a major roadway. HUSA staff confirmed the leak location with a geophone and by the presence of chlorinated water in a nearby storm manhole. This finding gave Dewberry the critical information they needed to provide the best guidance to the City. Excavation revealed the leak was located at the top of the pipe at a joint, so The City and Dewberry removed the bell/spigot and welded over the joint, resulting in a relatively simple solution to an expensive problem. Nautilus was able to pinpoint the source of the \$100k per year water loss within three feet of the marked-leak location and saved the City the cost of slip lining both pipes.

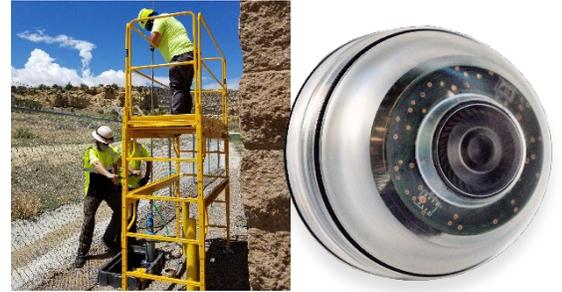
PRE-LAUNCH ASSEMBLY

Encompassing the full internal diameter of the pipeline, the Nautilus System catch net is installed prior to any insertion. The proper placement and alignment of the net is verified using a built-in camera system allowing real-time verification for field crews.

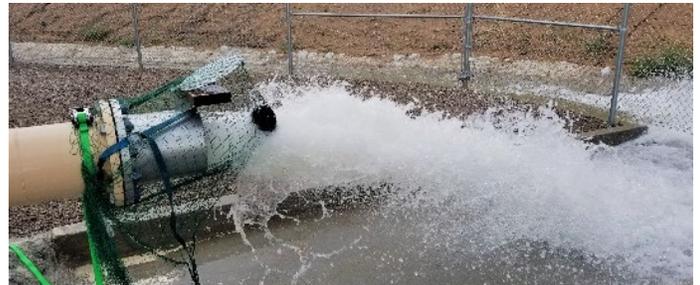
NAVIGATION

Once Nautilus has reached the end of the test, the team is alerted via camera and an alert system. It is captured in the net and safely removed from the pipeline.

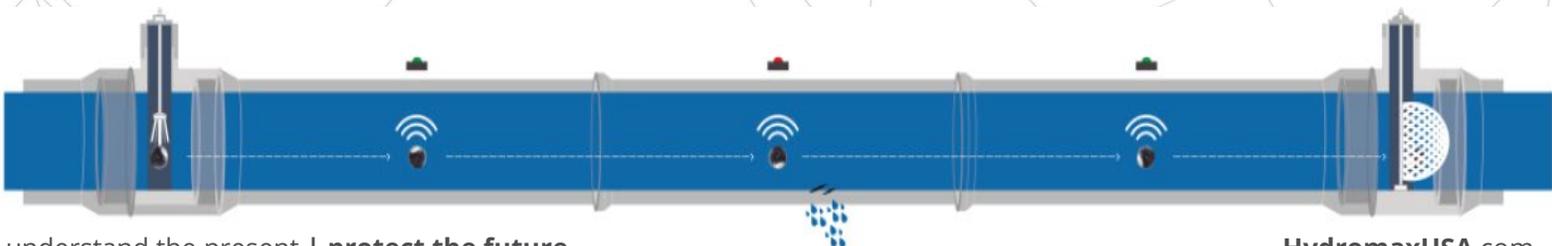
Once the sphere is extracted, the recorded sounds are processed and analyzed using the Nautilus Systems' proprietary algorithms. (The data contains different spurious noises that are filtered by several processing techniques.) The final inspection report provides for each identified leak, gas pocket, and anomaly a range of observations, including but not limited to:

- Acoustic recording supported by visual plot (Colorimetry) of the identified discrepancy.
- Prioritization level for each identified leak.
- GPS /GIS deliverable of all findings and all project appurtenances in ESRI compliant format.
